# Tameside MBC

## Flood & Water Management Act 2010 Section 19 Investigation Report

Wild Bank Hill Flood Event 21<sup>st</sup> November 2016

April 2017

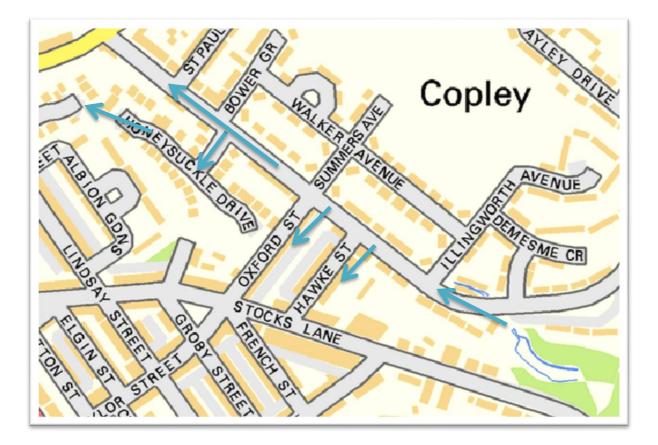
Plan showing flow of water

Demesne Drive is located in Stalybridge, east Tameside with Hollingworth/ Broadbottom to the south east and Mossley to the north. Stocks Brook runs off Fern Bank and the moorland of Wild Bank Hill, behind Mottram Old Road and into an inlet structure to the rear of 109-115 Demesne Drive, Stalybridge.

A total of 21 properties were flooded internally, with four sets of residents displaced. Additionally, five properties were externally flooded. Residents were affected on Demesne Drive, Hawke Street, Honeysuckle Drive, Lindsay Street and Oxford Street.

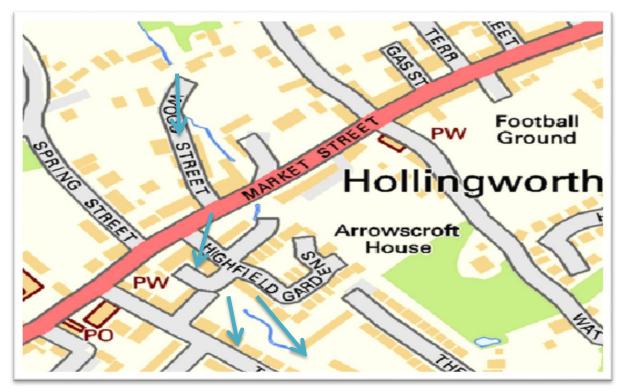
Plan showing flow of water

A total of 16 properties experienced flooding, with eight internally affected. Two residents were displaced on Arrowscroft Way. Properties on Thorncliffe Wood, Wood Street, Market Street and Highfield Gardens were affected.

An inlet structure to the rear of properties on Thorncliffe Wood was overwhelmed due to the amount of water flowing from the hillside. This brought debris with it, which in turn blocked the inlet grating and water surcharged to the surface and then along Wood Street before crossing Market Street and into Highfield Gardens.

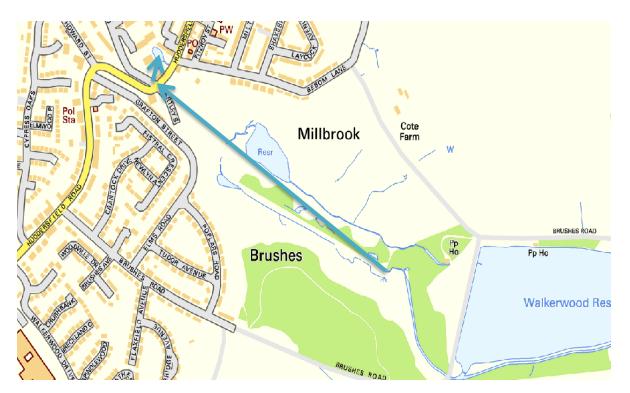
A culvert screen below Walkerwood Reservoir became blocked with debris following the heavy rainfall of the 21<sup>st</sup> November 2016. The water level increased and flowed over the parkland and onto Huddersfield Road. The properties are situated in a natural low point. Water washed through the houses, washing away a resident's drive and external boundary walls. UU cleared the inlet structure on the morning of the expected rainfall, then again within 48 hours of the event.

A total of two properties were flooded internally, both properties had extensive damage and residents were displaced as a result.

cleared inlet structure grating to allow more flow through main culvert and less into overflow system

cleared inlet structure screen

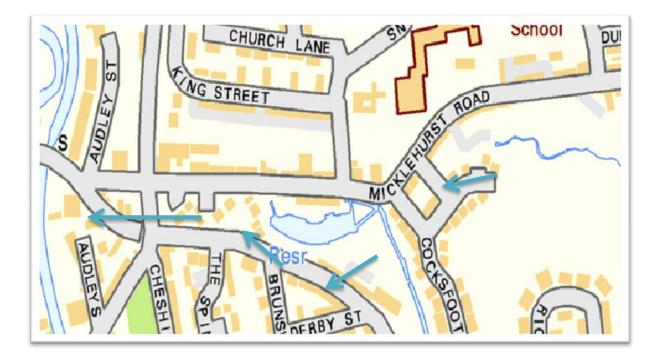
Plan showing flow of water

- an inlet structure to the rear of properties on Earnshaw Close was overwhelmed and blocked due to the volume of water, and the debris within the flow.

- the intense flow in the Staley Brook resulted in the flow from the Micklehurst Brook, which joins the Staley Brook, being restricted. This in turn resulted in the Micklehurst Brook surcharging.

- the overflow reservoir near to 9-27 Micklehurst Road saw levels rise quickly with the additional flow and breached the banking at the rear of properties on Micklehurst Road.

- in addition, the overflow inlet structure for the reservoir was also overwhelmed with the flow of water and debris.
