Mossley

River Flood Defence Inspection

Final September 2010

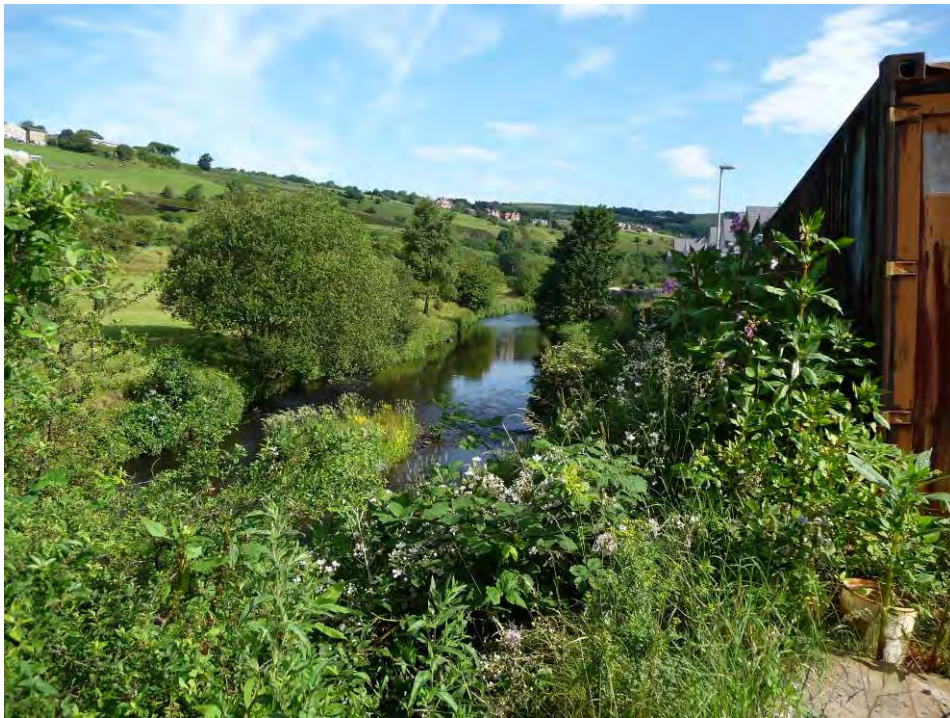
Plate 1 – View upstream from Tame Street

Chainage	Classification	Notes	Plate Number
<i>General Notes</i> <i>Approximately 80% of section inspected from Roaches Bridges and Tame Street with the aid of binoculars.</i>			
Right Channel			
0 - 420	Natural channel (lightly vegetated)	Naturally grassed with occasional trees, the right channel is approximately 1m lower than the left channel. At Roaches Bridge, road level is at least 5m higher than the normal river level. No sign of instability due to erosion at base of bank or oversteep banks	1 - 3
Left Channel			
0 - 420	Natural channel (lightly vegetated)	As right channel	1 - 3

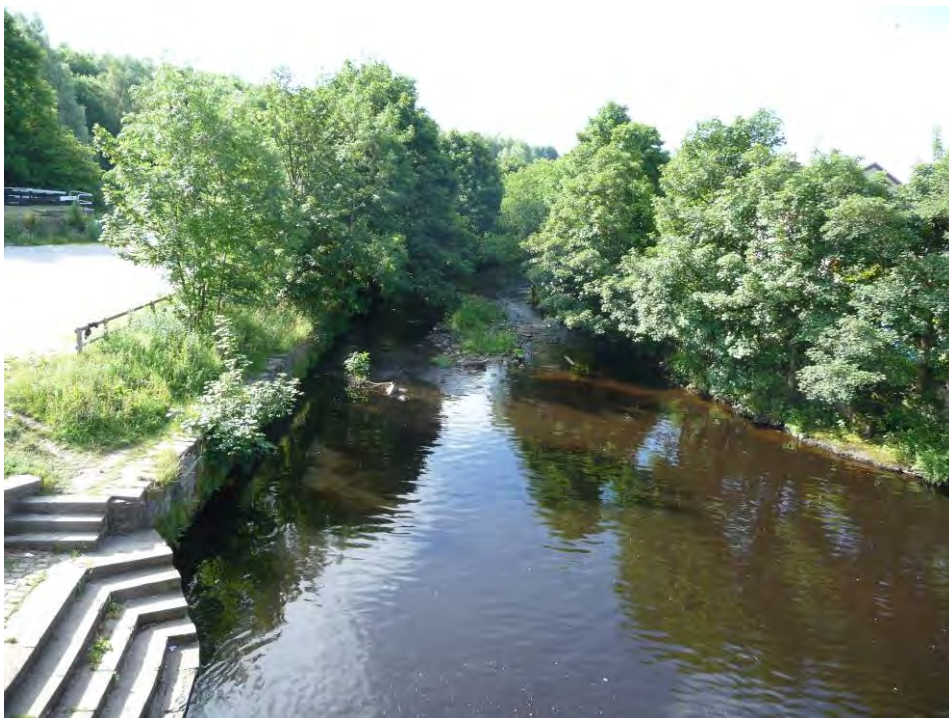
Plate 4 – View downstream from Roaches Bridge

Chainage	Classification	Notes	Plate Number
<i>General Notes</i> <i>Approximately 95% of section inspected from Roaches Bridge and footpath on left bank</i>			
Right Channel			
420 – 560	Natural channel (lightly vegetated)	Grassed channel No sign of instability due to erosion at base of bank or oversteep banks	4 - 5
560 – 1060	Masonry lined channel	Intermittent stone walls of varying height, but never extending above bank level Reasonable condition with vegetation growth	8 - 10
1060 – 1340	Raised defence	Stone walling extending of varying height above bank level bank level, tying into footbridge at Winterfold Lane at downstream end but open at upstream end.	11 - 13

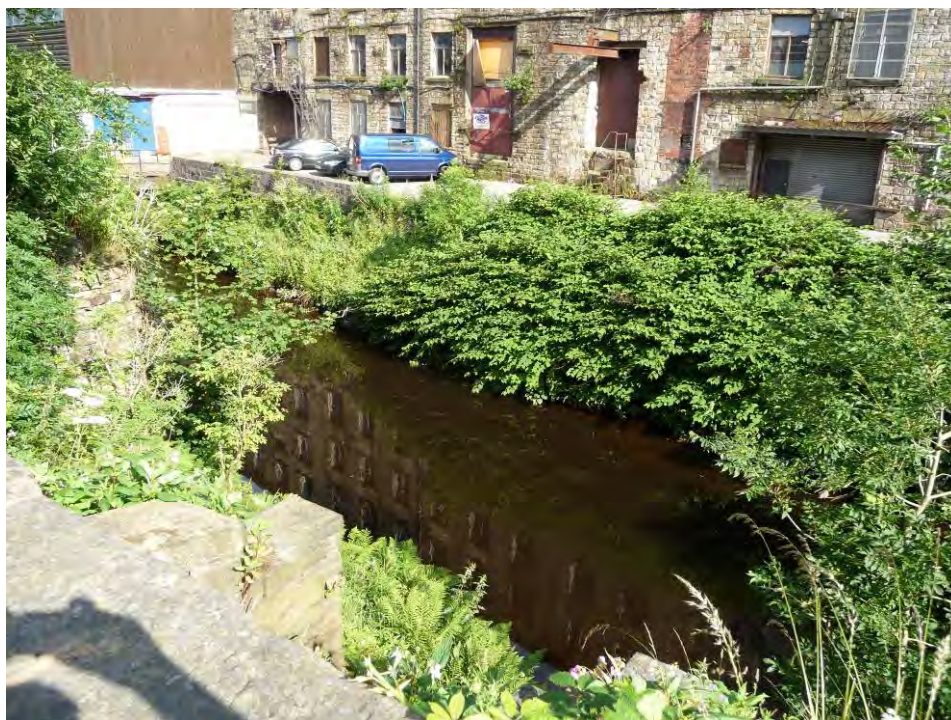
Plate 11 – Typical right channel alongside mill

Reasonable condition with some vegetation growth, but no signs of instability Due to height differences and some gaps, would not function as a flood defence structure	
Left Channel			
420 – 475	Masonry lined channel	Masonry lined channel and steps from adjacent car park to the river. Excellent condition, no vegetation and approximately 1m high	4 - 7
475 – 1075	Natural channel (lightly vegetated)	Grassed channel, typically lower than right channel with large plateau area between river and canal. No sign of instability due to erosion at base of bank or oversteep banks	8 - 10
1075 - 1340	Raised defence	Stone walling extending approximately 1m above bank level, tying into footbridge at Winterfold Lane at downstream end but open at upstream end. Good condition with some vegetation growth, but no signs of instability	11 - 13

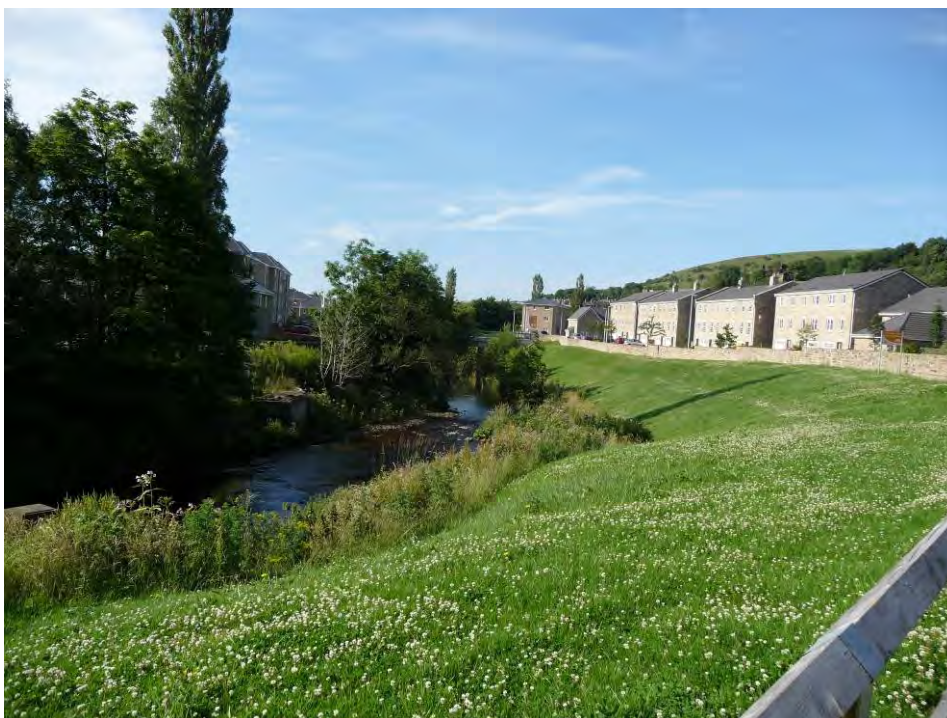
Plate 14 - View downstream from Winterfold Lane footbridge

condition but no signs of instability	
Left Channel			
1340 - 1405	Masonry lined channel	Short section of relatively new stone walled vertical channel immediately south of Winterfold Lane footbridge	14 - 16
1405 - 1795	Natural channel (lightly vegetated)	Tree-lined channel No sign of instability due to erosion at base of bank or oversteep banks	16, 18
1795 - 2160	Raised defence	Stone walling approximately 1m high above bank crest Excellent condition, tying into buildings at downstream end, however, no tie in at upstream end	19 – 21, 28

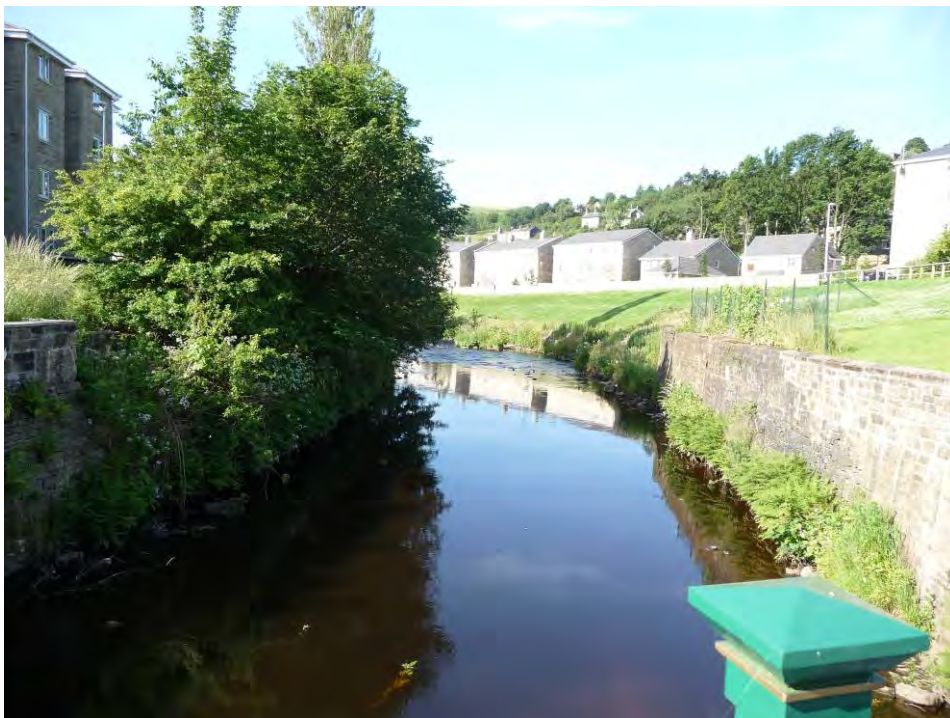
Plate 16 – View downstream from Winterfold Lane footbridge

Chainage	Classification	Notes	Plate Number
General Notes <i>Approximately 80% of section inspected from Waggon Road bridge, Dark Lane bridge and Three Counties Road with the aid of binoculars.</i>			
Right Channel			
1340 - 1400	Masonry lined channel	Short section of relatively new stone walled vertical channel immediately south of Winterfold Lane footbridge	14 - 16
1400 - 1830	Natural channel (lightly vegetated)	Tree-lined channel No sign of instability due to erosion at base of bank or oversteep banks	16, 18
1830 - 2160	Masonry lined channel	Stone / brick vertical channel, varying height and	19 – 21, 28

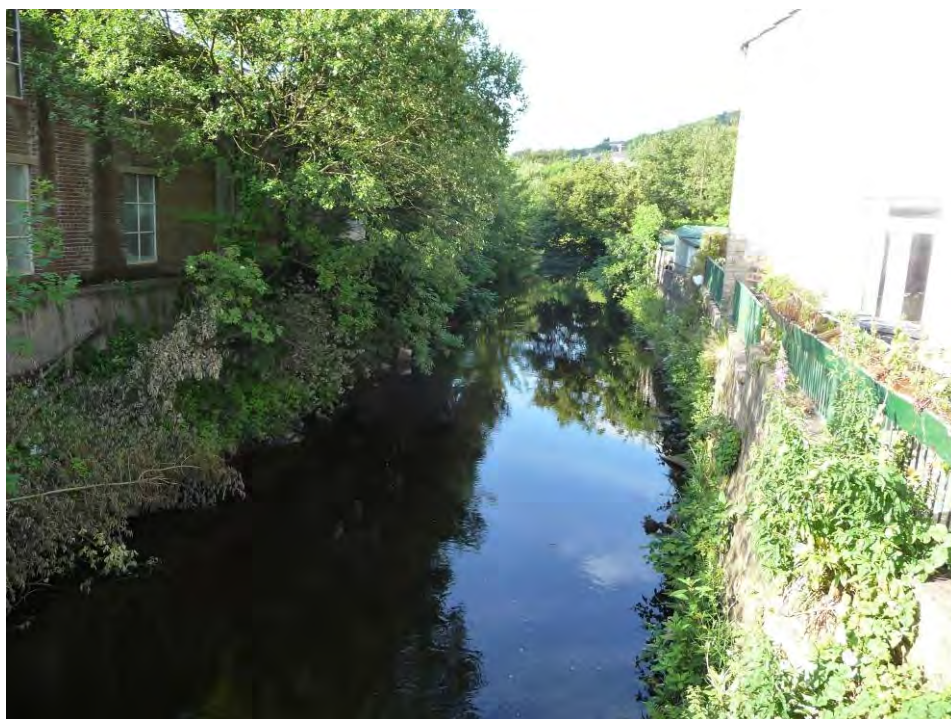
Plate 29 - View downstream from Waggon Road bridge

Chainage	Classification	Notes	Plate Number
General Notes Approximately 95% of section inspected from Waggon Roadbridge, Egmont Street bridge and footpath on right hand bank.			
Right Channel			
2160 - 2305	Masonry lined channel	Inspection difficult due to dense vegetation and lack of access Stone / brick vertical channel, varying height and condition but no signs of instability	29
2305 - 2500	Natural channel (heavily vegetated)	Inspection difficult due to dense vegetation and lack of access No sign of instability due to erosion at base of bank or oversteep banks	30
Left Channel			
2160 - 2500	Masonry lined channel	Inspection difficult due to dense vegetation and lack of access Stone / brick vertical channel, varying height and condition but no signs of instability	29 - 30

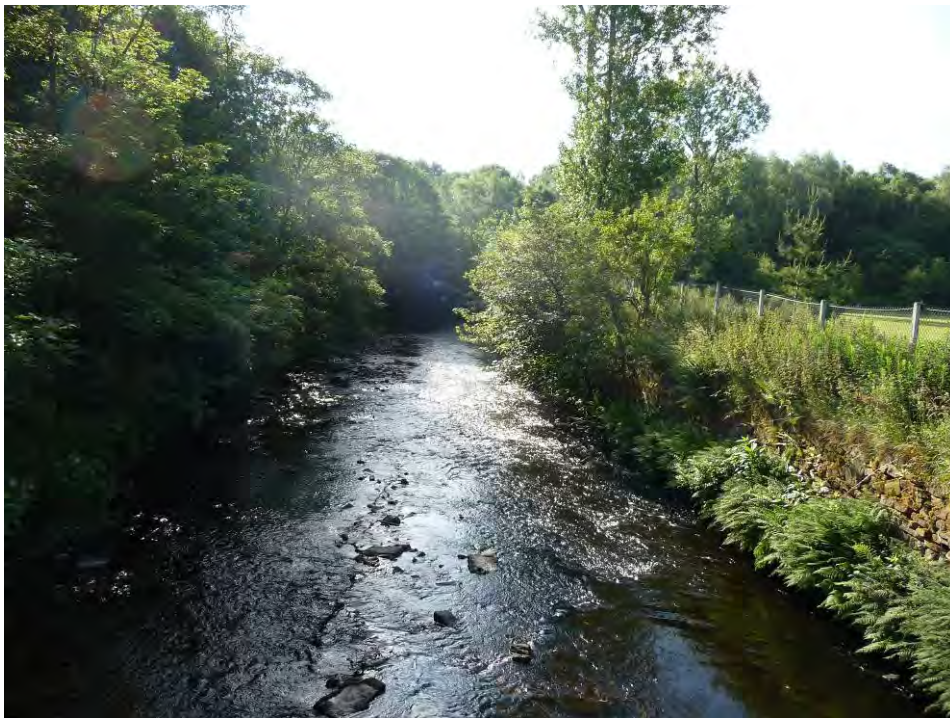
Plate 31 - View downstream from Egmont Street bridge

Chainage	Classification	Notes	Plate Number
<i>General Notes</i> <i>Approximately 70% of section inspected from Egmont Street bridge with the aid of binoculars.</i>			
Right Channel			
2500 - 2580	Natural channel (lightly vegetated)	Naturally grassed with occasional trees No sign of instability due to erosion at base of bank or oversteep banks	31
2580 - 2780	Masonry lined channel	Stone / brick vertical channel, varying height and condition but no signs of instability	31
Left Channel			
2500 - 2615	Masonry lined channel	Stone / brick vertical channel, varying height and condition but no signs of instability	31
2615 - 2780	Natural channel (lightly vegetated)	Naturally grassed with occasional trees No sign of instability due to erosion at base of bank or oversteep banks	31

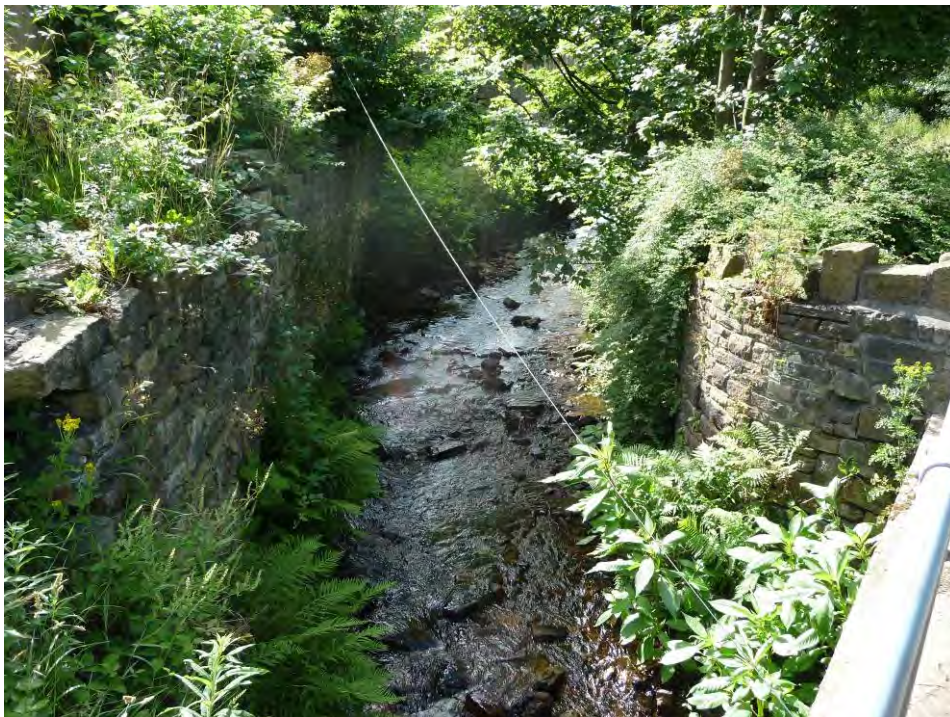
Plate 32 – View upstream along Carr Brook from Micklehurst Road

Chainage	Classification	Notes	Plate Number
<i>General Notes</i> <i>No-culverted lengths inspected from Micklehurst Road.</i>			
Right Channel			
0 - 140	Natural channel (lightly vegetated)	Natural, grassed channel approximately 1.5m deep and a maximum of 3m wide.	32 - 34
140 - 190	Raised defence	Stone lined channel, with back of footpath stone wall, approximately 1m high, providing a defence structure and tying into houses at downstream end	35 - 38
190 - 440	Culvert	No inspection, outflow at River Tame adjacent to Waggon Road bridge	39 - 40
Left Channel

0 - 140	Natural channel (lightly vegetated)	Natural, grassed channel approximately 1.5m deep and a maximum of 3m wide.	32 - 34
140 - 190	Masonry lined channel	Stone lined channel, good condition	35 - 38
190 - 440	Culvert	No inspection, outflow at River Tame adjacent to Waggon Road bridge	39 - 40
