Geoenvironmental Report

A Proposed Residential Development

Wellington Works, Wellington Road

Ashton under Lyne, Lancashire

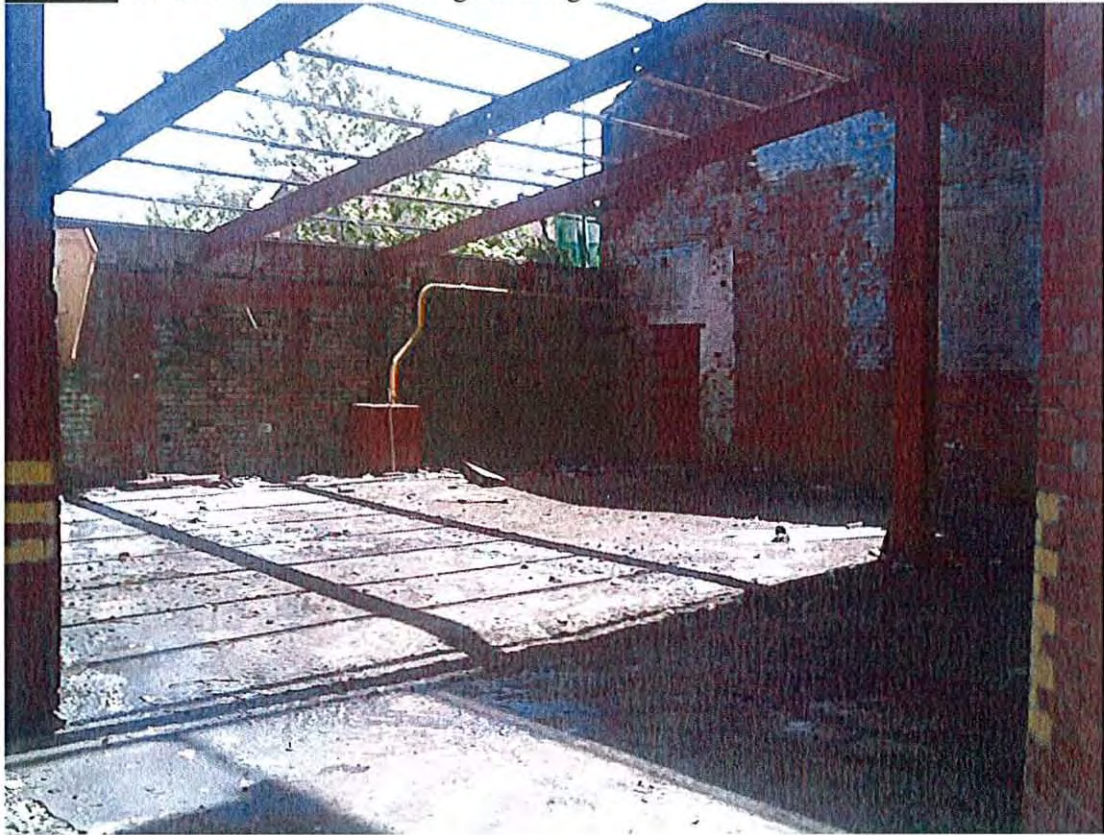
Figure 1 A view inside the existing building on the North eastern corner of the site.

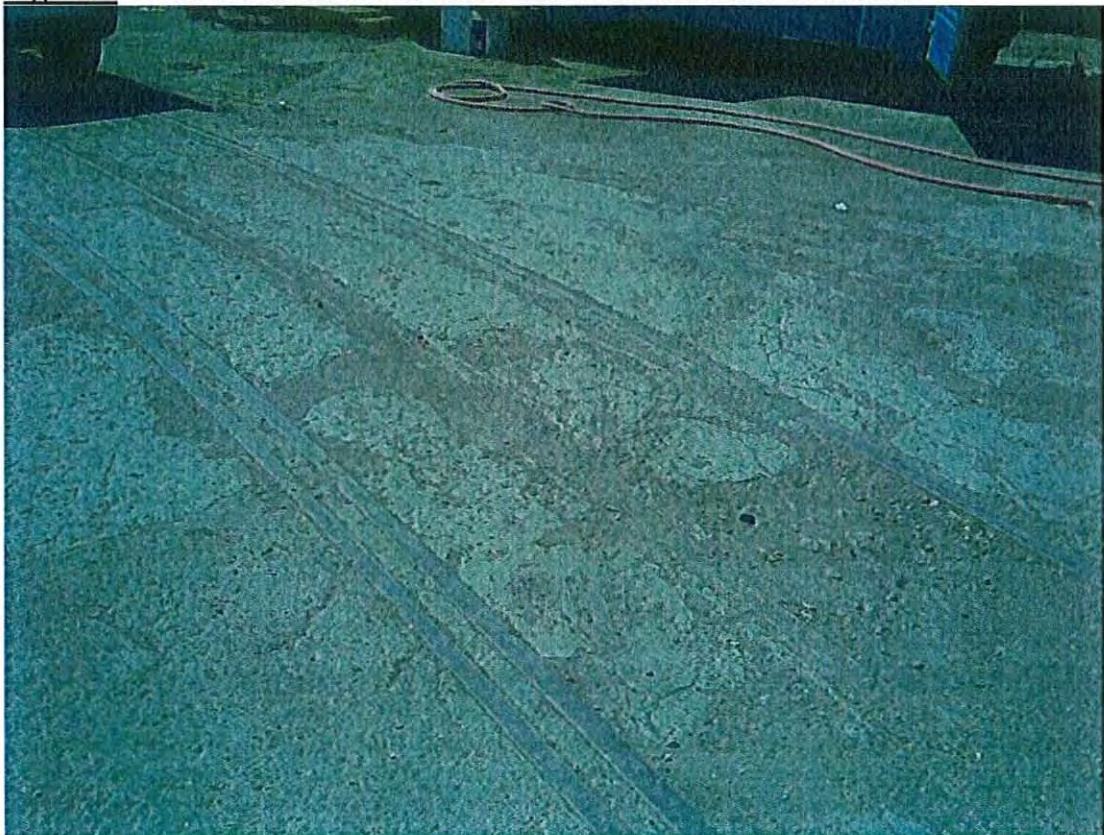
Figure 4 Evidence of rail tracks on the north western corner of the site.

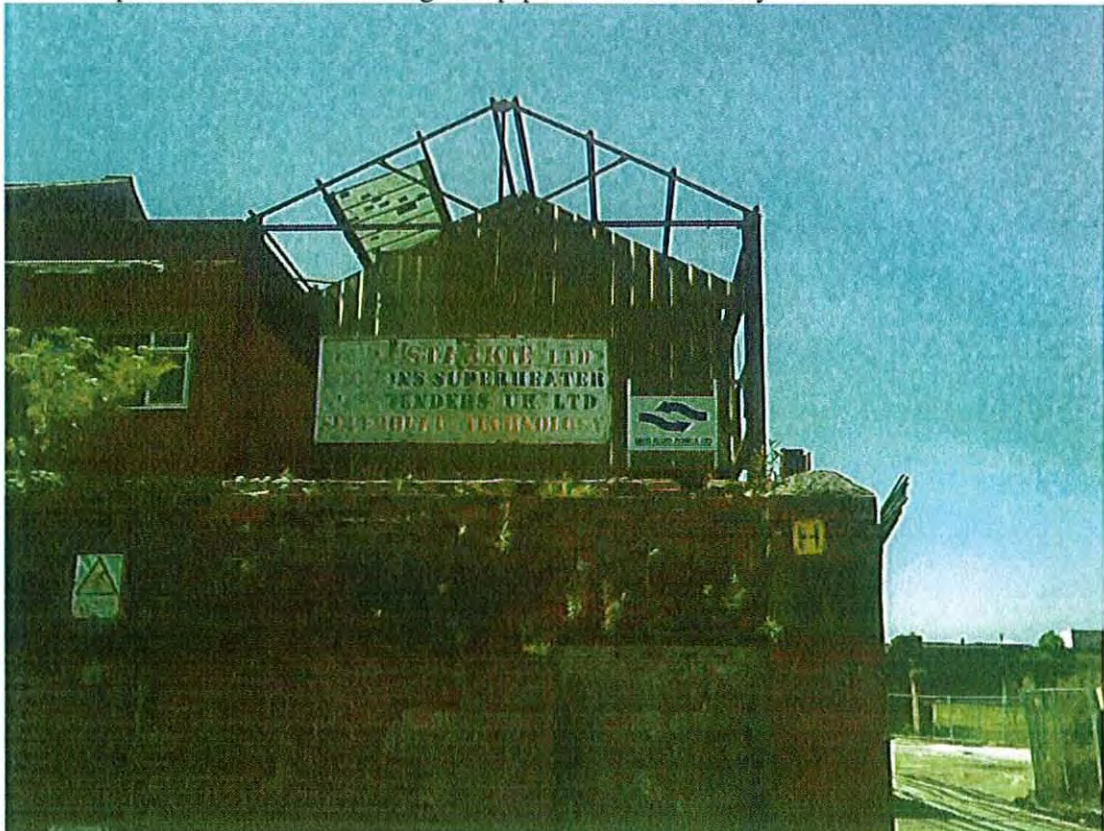
Figure 16 A view from outside the north eastern access gates to the site indicating the sites previous use as a heating and pipe benders industry.

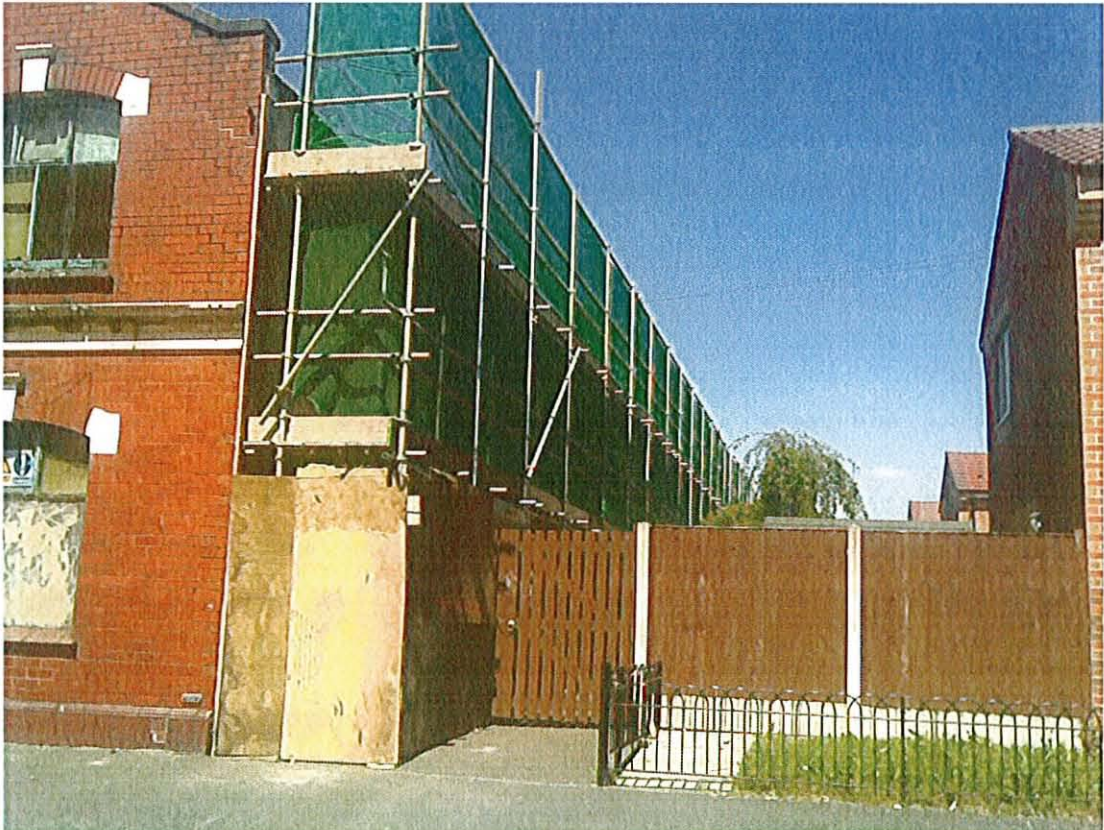
Figure 18 A view of the south eastern boundary of the site which borders with housing to the immediate east of the site. The building on the east of the site is being demolished at this time.

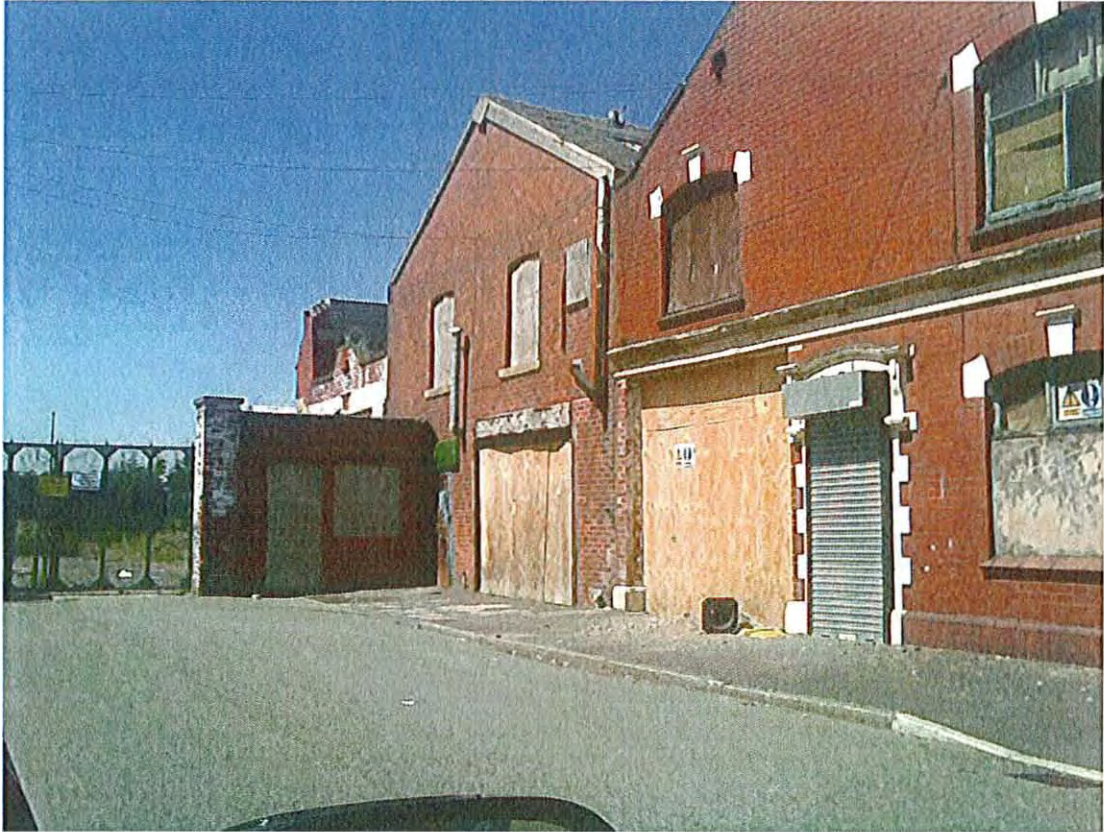
Figure 19 A view of the eastern building on site from the south east, also the south eastern access gates to the site leading from Uxbridge Street.
