# Tameside MBC

## Flood & Water Management Act 2010 Section 19 Investigation Report

Wild Bank Hill Flood Event 21<sup>st</sup> November 2016

April 2017

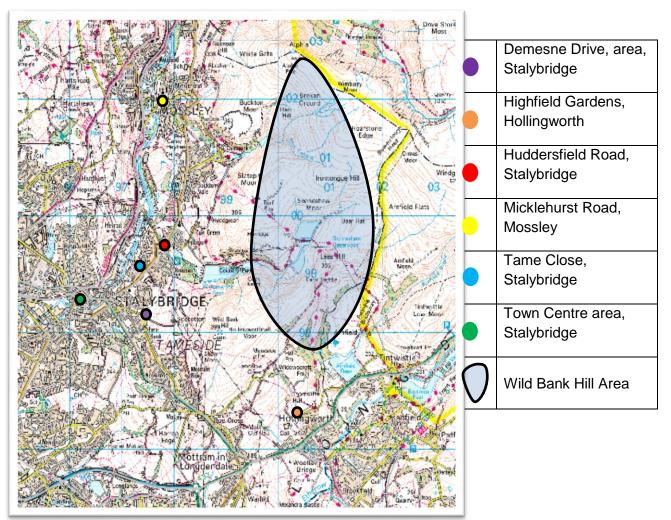
The plan below shows the general locations of properties affected following the flooding event of 21<sup>st</sup> November 2016 and the location of Wild Bank Hill. These numbers were confirmed by the EA, however, the numbers may be higher given locations where residents were unavailable or flooding was not reported.

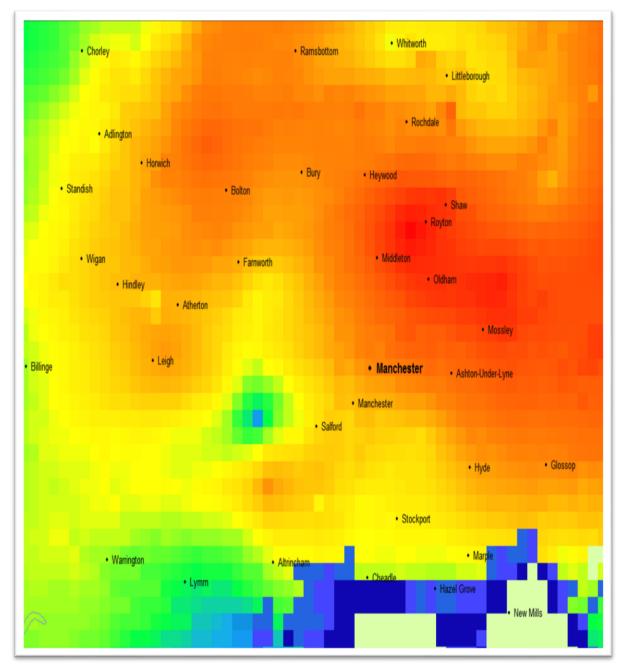
#### Greater Manchester 17:30 21<sup>st</sup> November 2016

The Hyrad images shows that the intensity of the rainfall was centred on the east of the borough –

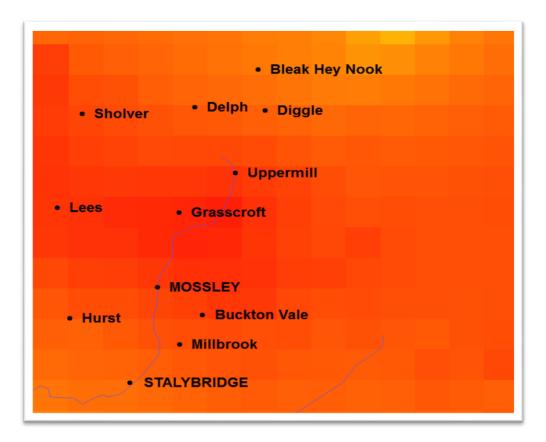
East Tameside 17:30 21<sup>st</sup> November 2016

The Hyrad image below shows the intensity of rainfall across Stalybridge and Mossley.

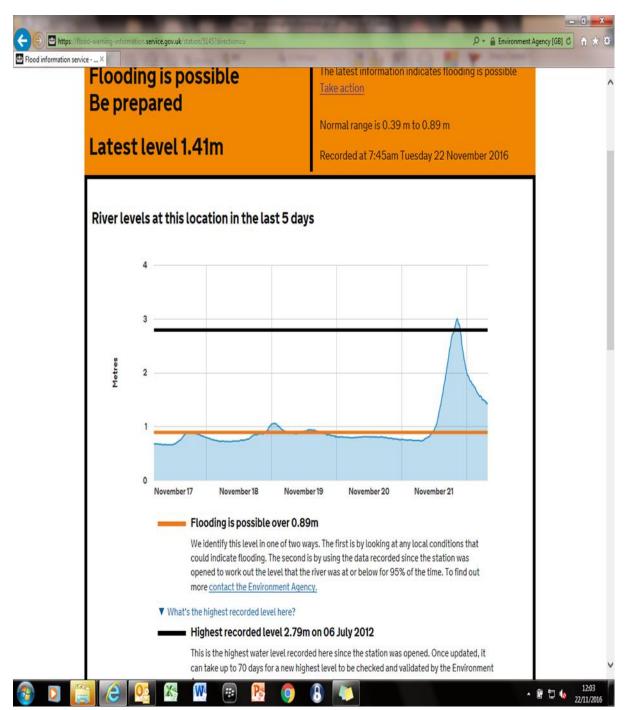
Screen shot Waggon Road River Tame monitoring site, 17<sup>th</sup> – 22<sup>nd</sup> November 2016

On the 21<sup>st</sup> November 2016, a peak level of 3.011m was recorded at 20.30 at Waggon Road, Mossley. This had quickly risen from 0.783m at 08.30 the same day.
